# **RE: Approval of Fusion Plast Electro Fusion Fittings**

# TECHNICAL SERVICES TEST REPORT

**Subject:** Approval Testing of Fusematic PE100 125mm x 32mm saddle and two

Fusematic PE 100 125mm caps

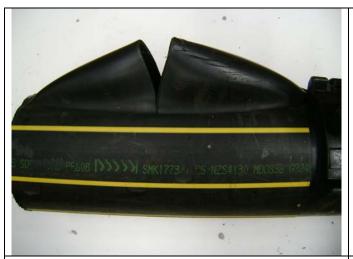
The test continued for 134 hours instead of 165 hours required because the pipe burst. During this 134 hours period, the assembly remained leak-tight. The pipe (PE80B) failure was found to be due to application of excessive hoop stress. The PE80B used for testing was found to have been manufactured at the lower extremity of wall thickness of 10 mm, which must have also contributed to the failure of the pipe. Based on an internal pressure of 1104 kPa and wall thickness of 10 mm pipe, the hoop stress applied to the assembly became 6.3 MPa instead of 4.5 MPa (equivalent to an internal pressure of 900 kPa).

The Fusematic PE100 samples submitted for leak-tight testing were satisfactory for the duration of the testing, which had to be terminated at 134 hour because of the PE80B pipe burst. The failure was due to excessive hoop stress applied to the pipe.

Fig. 1 Burst PE 80B pipe
