SHELL COVE BOATHARBOUR STAGE 2 AND BREAKWATERS MONTHLY MONITORING SUMMARY April 2019

COASTWIDE CIVIL PTY LTD

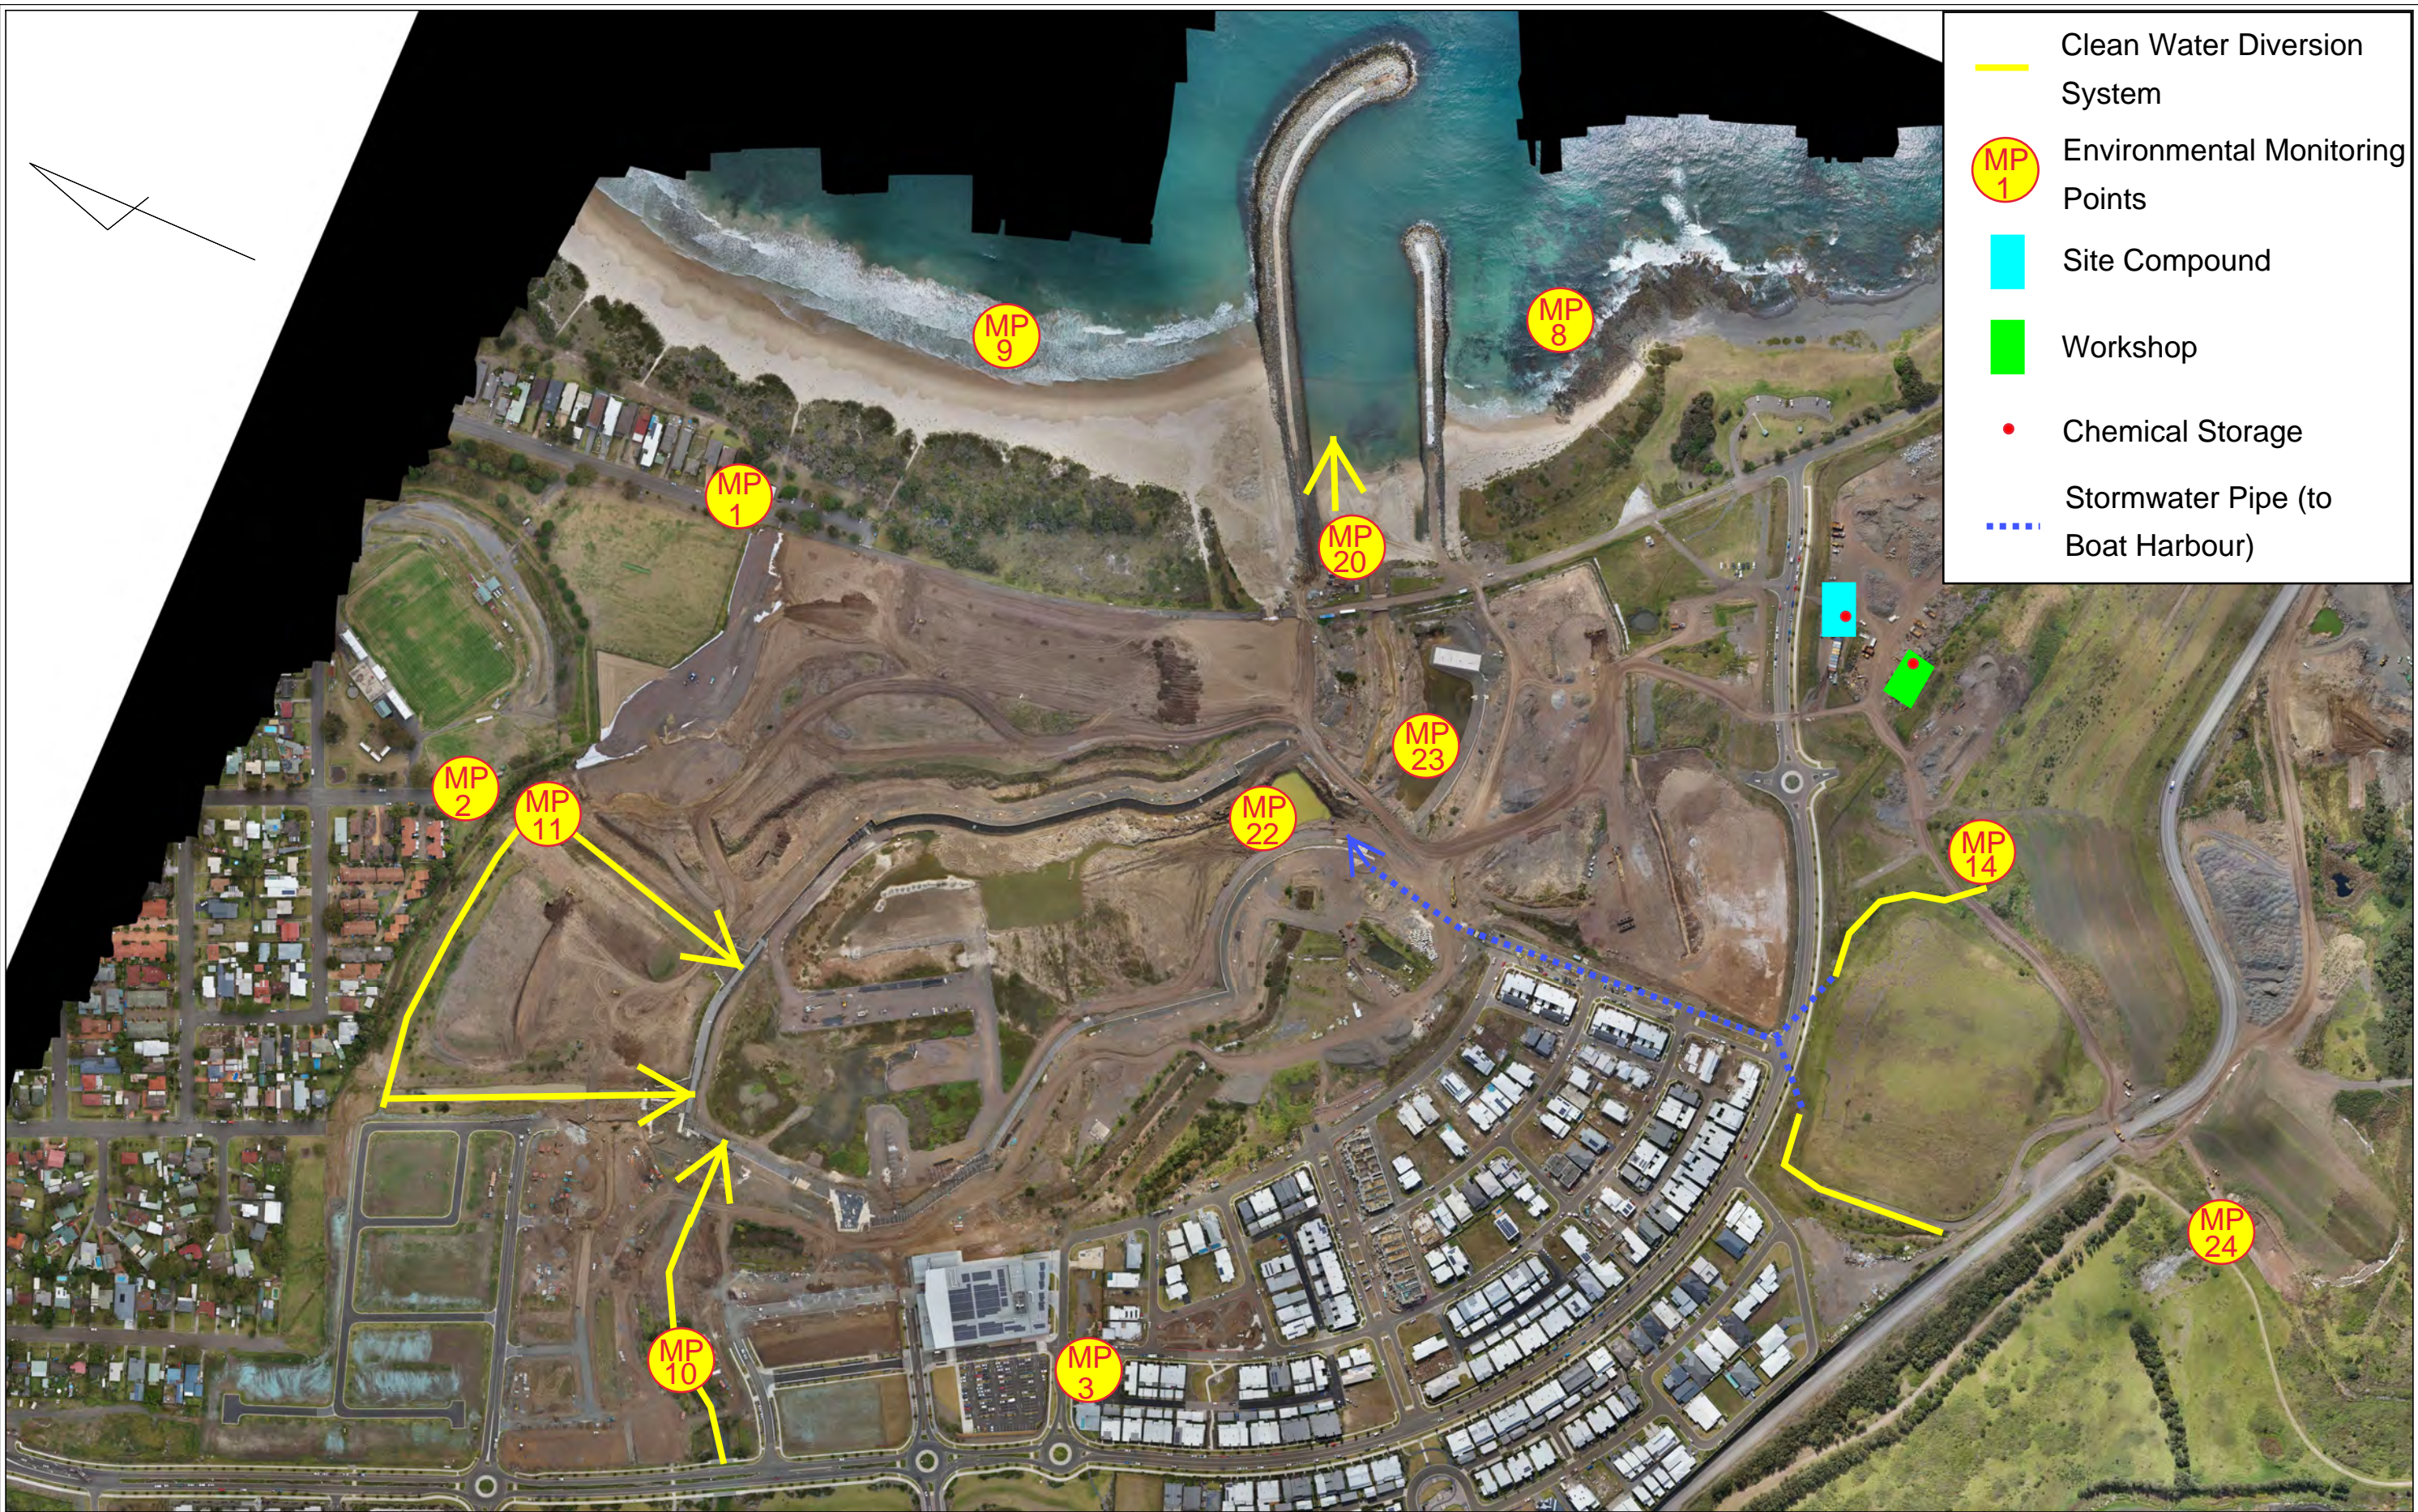
Appendix A
– Site Map

- Clean Water Diversion System
- MP 1 Environmental Monitoring Points
- Site Compound
- Workshop
- Chemical Storage
- Stormwater Pipe (to Boat Harbour)
